Project Title: Analysis of Field Coil Failure

PROJECT NO. A 760-206

FAILURE ANALYSIS OF A HYDROELECTRIC GENERATOR
STRAP FIELD COIL

U. S. ARMY CORPS OF ENGINEER
U. S. ARMY ENGINEER DISTRICT, MOBILE
MOBILE, ALABAMA 36628

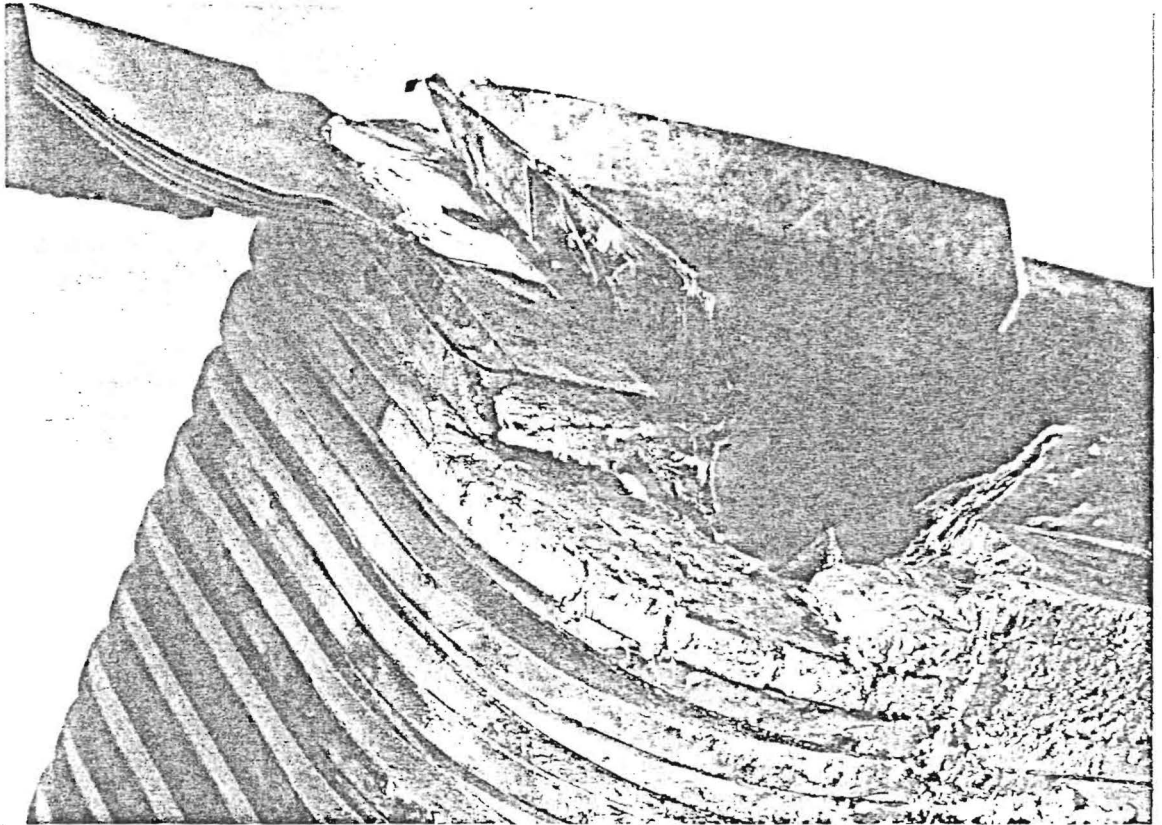
The hydroelectric generator strap field coil which was submitted to the Analytical Services Branch of the Engineering Experiment Station of Georgia Tech on August 5, 1977, for failure analysis has been examined using a variety of analytical techniques. This crossed coil had failed by electrical burn out which completely melted away the corner area of two turns near the bottom connector as shown in Figure 1. The results of this analysis indicate no material defects in the coil and have not shown cause for this failure.

This analysis has shown that the copper coil has probably reacted with some iron during the failure. While it is obvious by inspection of the coil that arcing has occurred between the coil and the pole piece, it is believed that the iron found in the melted and resolidified copper which ran between the mica and the coil away from the arc over region would indicate a reaction of the copper with some iron part early in the time span of the failure. However none of the analyses has revealed a possible cause for failure initiation.

Figure 1: Burned coil

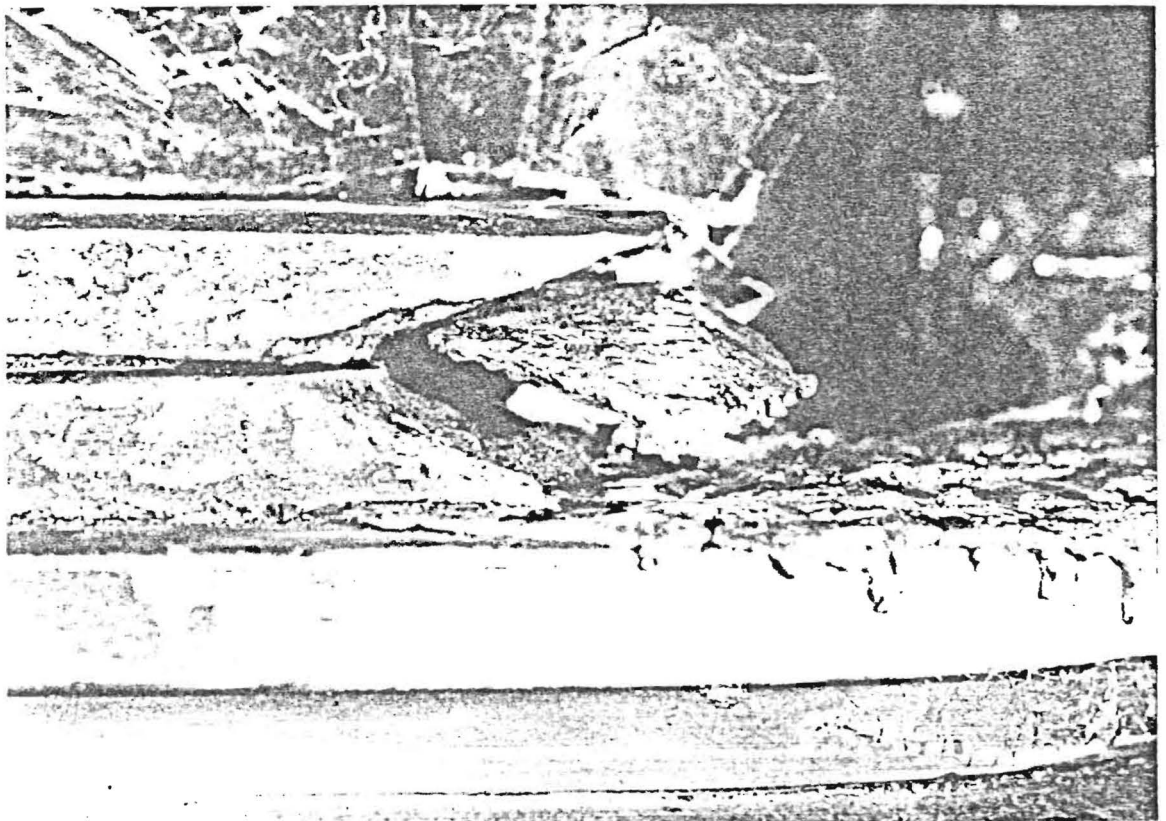
The coil was first examined in the as received condition for any visible clue such as obvious defects, unusual coloration, and condition of the insulation. A "tongue" of material was observed on the side of the burn out area nearest the connector, see Figure 2, which appeared unusual. A portion of the last turn including the connector and the "tongue" was removed from the coil for closer examination. The "tongue", as shown in Figures 3 and 4, was then identified as being the result of the failure of the silver brazed joint which is present in this area as shown in detail GR4 of the Westinghouse blue print No. 7149D78. The "tongue of material was removed from the main body and a portion of the brazed surface cut out for examination in the scanning electron microscope (SEM). This surface was anlyszed in the SEM using an energy dispersive x-ray analyzer and all areas checked showed elements consistent with the elemental content of Sil Fos braze with perhaps an excess of

Figure 2: "Tongue" at edge of burn out

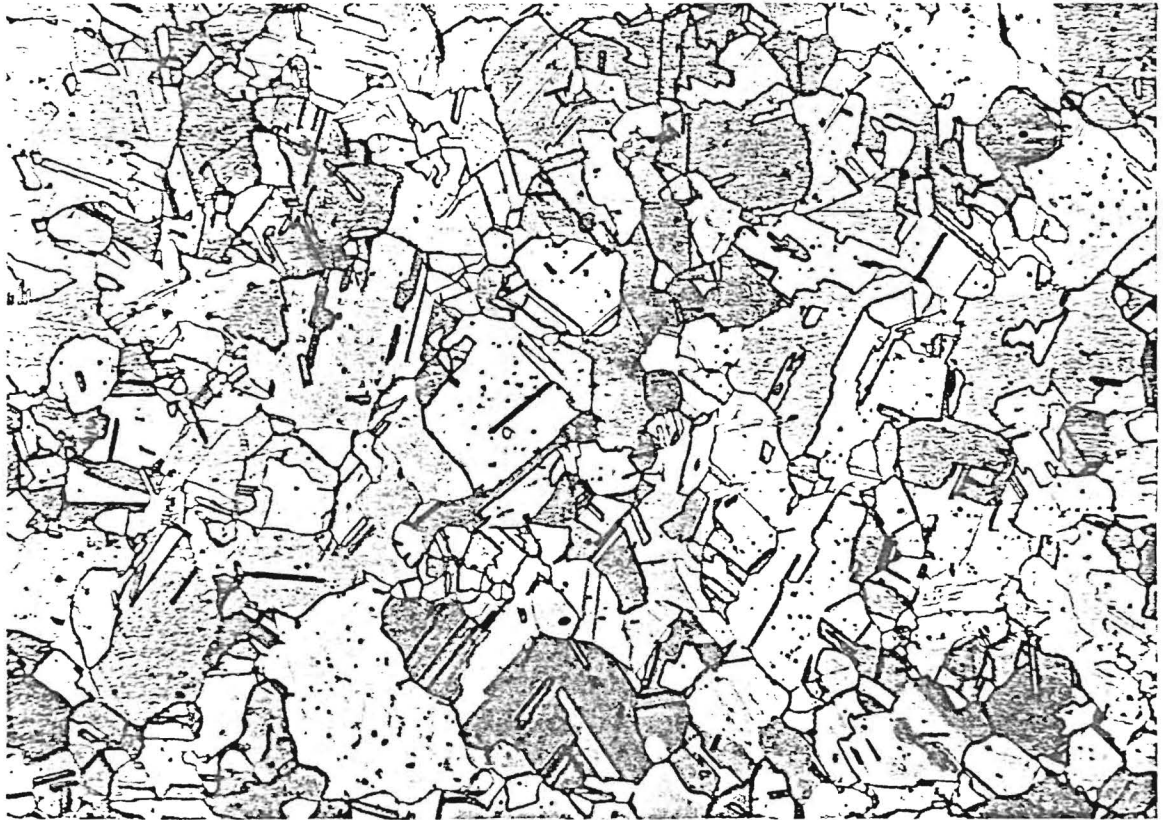
The copper material itself was suspect and the condition of the burn out corner in a questionable mechanical state due to the lack of first hand knowledge of the amount of deformation, if any, which it may have been given during attachment of the connector. In order to check the material and the possibility of microcracks after deformation, the remainder of the last half turn from which the connector corner had already been removed was pried loose from the coil. The short tapered end was placed in a vice and the corner bent approximately 30° and rebent to its original position. A section was taken from the center of the turn which was mounted, polished, and etched. This etched section was then studied with an optical microscope. The structure, as shown in Figure 5, appears normal and no microcracks were evident.

Figure 5: Copper structure (150X)
